**FINAL FOCUSED FEASIBILITY STUDY
FOR GROUNDWATER
ALASKA REAL ESTATE PARKING LOT
ANCHORAGE, ALASKA**

**ADEC SPAR TERM CONTRACT #18-8036-13
NOVEMBER 11, 2014**

**Ahtna Engineering Services, LLC
110 West 38th Avenue, Suite 200A
Anchorage, Alaska 99503**

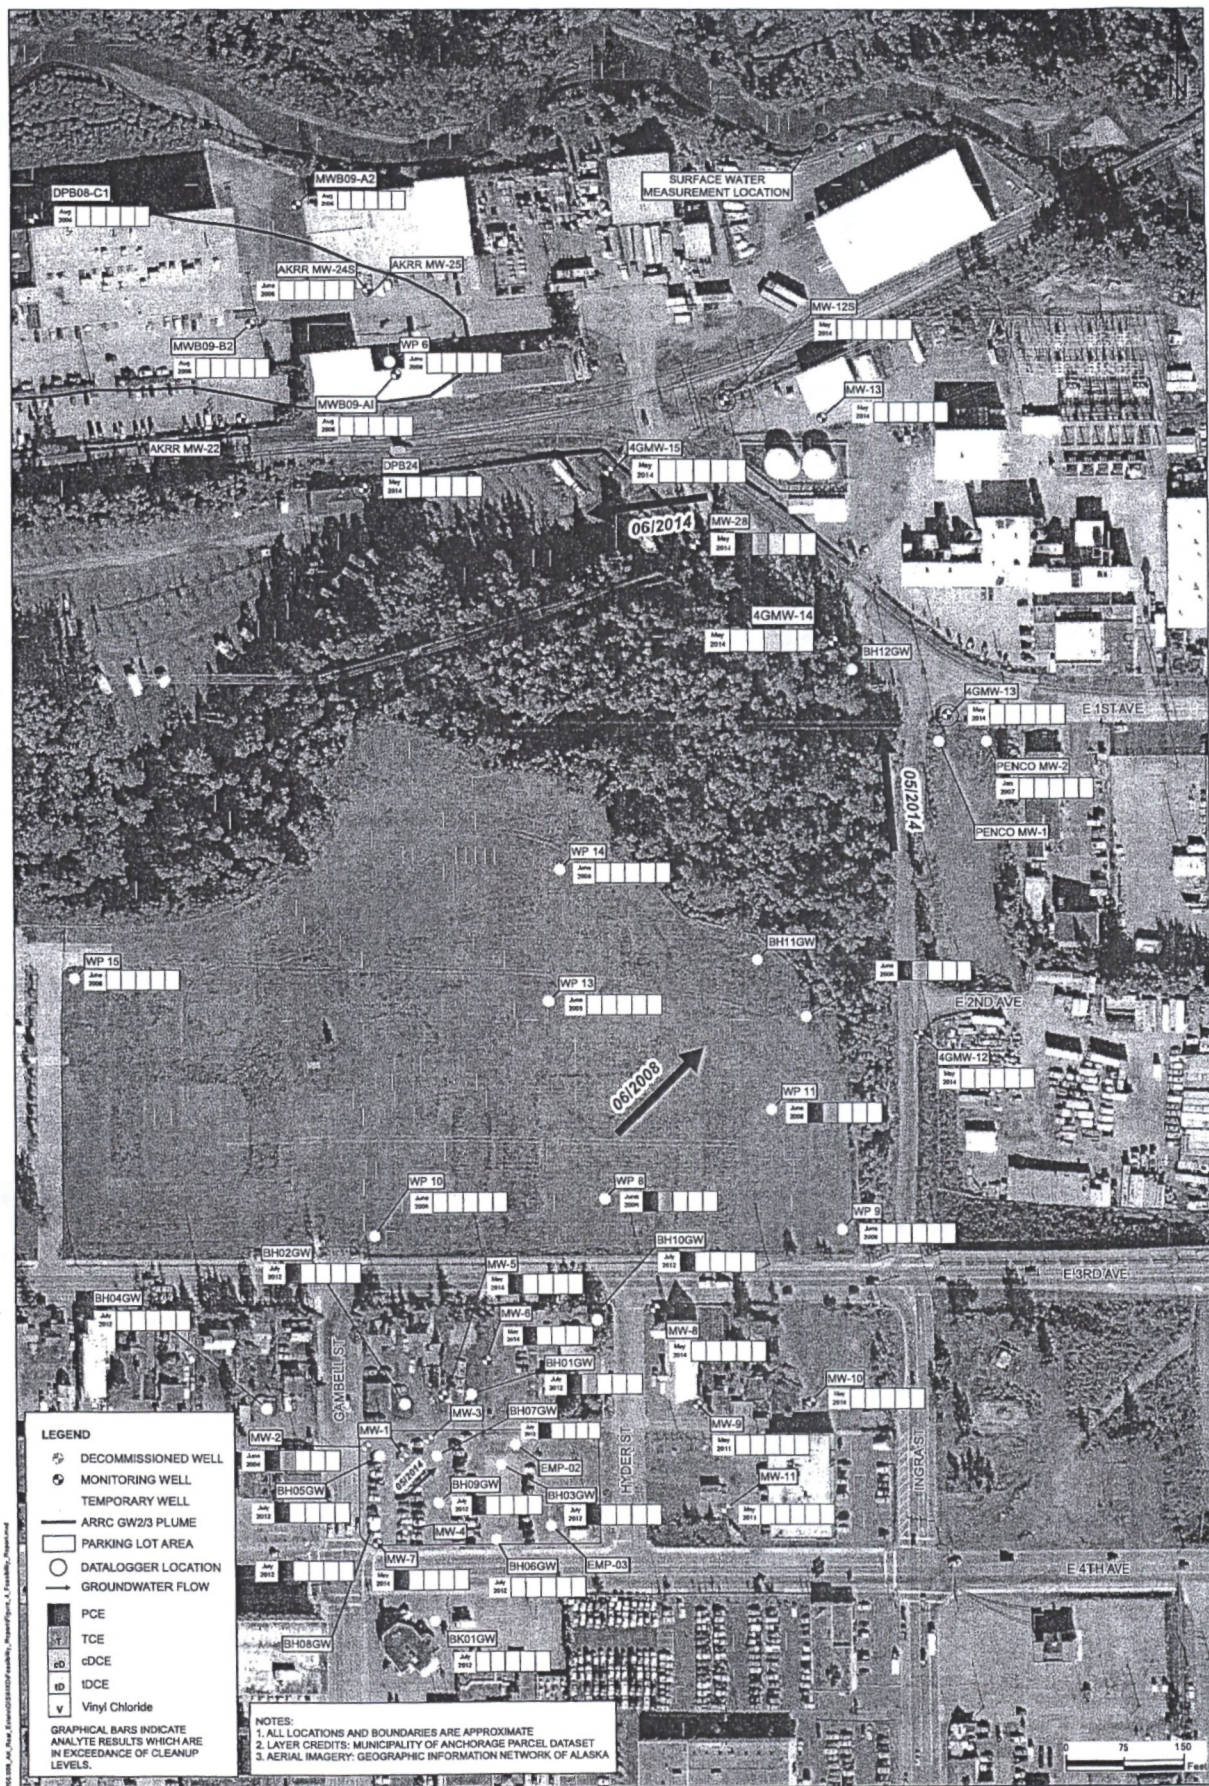
GROUNDWATER PLUME

Based on the static groundwater measurements taken during the 2008 Area GW 2/3 Supplemental Groundwater Investigation (CH2M Hill and E&E, 2008), the general local groundwater flow direction is toward the northeast (Figure 4). Local variations in the groundwater flow directions are noted with a more northwesterly direction on western portion of the former Native Hospital property, a more northeasterly direction on the eastern portion of the

Investigations conducted prior to 2014 have generally concluded that the Alaska Real Estate Parking lot PCE-contaminated groundwater has migrated to the northeast in the direction of groundwater flow with little biological degradation, eventually intercepting with petroleum contamination located beyond the bluff. After interception with the petroleum, the plume undergoes biological degradation to the daughter products TCE, DCE, and VC as seen in MW-28. However, data collected during the focused groundwater investigation in 2014 are compelling that while PCE-impacted groundwater from the Alaska Real Estate Parking Lot may be contributing to the concentrations in MW-28, there is likely another source in the downgradient area migrating from the east. For this reason, and because the primary risk exposure is located in the residential area, only the source area of the Alaska Real Estate Parking Lot, located between Third and Fourth Avenues and Gambell and Hyder Streets will be addressed in the FFS.
